Heinkel He 115

~ Paint and Colour Analysis ~
Flyhistorisk Museum Sola

Heinkel He 115 WerkNr. 2398

Sola - Stavanger, Norway Analysis of Paint Samples (12.07.2014) Erik Pilawskii, Report

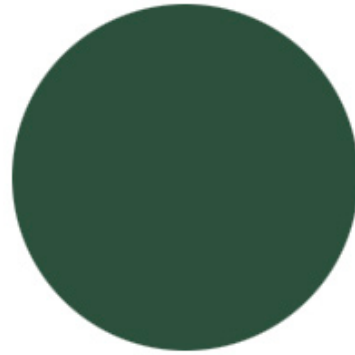
Paint #1 "Marine Green, lighter" (RLM 73)

Specific Ph: 7.6

Surface Finish (MPI 60°): matte(v) - 8GU

Lacquer Base: Alkyd Enamel

This is the lighter green shade of the original camouflage pattern applied to 2398, which according to *Luftwaffe* documentation should have been RLM 65/72/73. I believe that the evidence on 2398 confirms this assertion perfectly, and therefore we may assume that this paint was certainly RLM 73 Grün.

The pigment was notable for the healthy amount of blue in the colour, which was slightly more than anticipated.

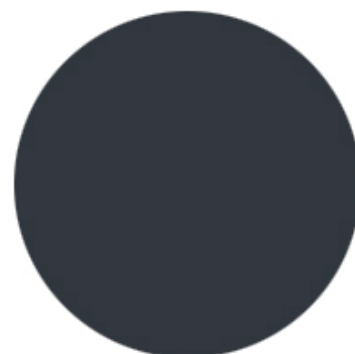
Paint #3 "Applique Dark Grey" (RLM 66)

Specific Ph: 7.6

Surface Finish (MPI 60°): matte(v) - 6GU

Lacquer Base: Alkyd Enamel

A very considerable amount of re-painting was undertaken on 2398, and at some point in its history a new camouflage was applied to replace the original 65/72/73 livery. The lower surface RLM 65 was replaced with RLM 02 Grau, while the upper surface greens were replaced with two dark grey colours. The lighter of these was found across the entire upper surface, and upon inspection this would certainly appear to be RLM 66 Schwarzgrau. Pigment samples from the exterior were compared to a sample taken from the interior nose area (which should be 66 according to documentation), and these were found to be identical.

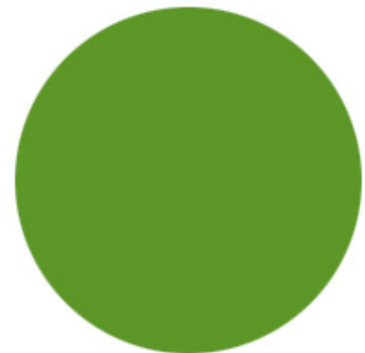
Paint #6 "Mystery Bright Green"

Specific Ph: 8.8

Surface Finish (MPI 60°): gloss - 80GU

Lacquer Base: Acetate or Synthetic (?) Enamel (not very soluble)

This bright green paint had a very high Ph value, which is inconsistent with the usual aviation type lacquers we see during the 1930-50 period. The enamel itself is virtually indestructible-- I could not grind it in a mortar and had to smash the lacquer grains with a hammer! Moreover, the paint did not solve especially well in white spirit (only a bit), and as a result I did not successfully extract any usable quantities of pigment to analyse. The finish was quite gloss, adding to its hardness. Taking into account these various characteristics, this paint was reminiscent of typical marine use varnish (hull varnish, in particular) and not aviation lacquer. I believe that it is indeed marine boat paint [see Appendix 2].

However, I feel that the colour is sufficiently "fresh" even now to understand the original appearance, which can be seen in this digital chip.

As a result, it seems clear that quantities of British boat varnish were available in Norway, and likely in use for various marine applications. Although presently no copies of Ryland's period (1930-40) colour chip booklets have been found, it is nevertheless fascinating to note that this unknown bright green colour is very similar to a paint in their current (Llewellyn-Ryland) range, #11038 Grass Green. It is also remarkably similar to a colour from the *old* RAL colour system (pre-1954), index #6014, which Ryland has confirmed was used (RAL colour) during the 1930s-40s by their company.

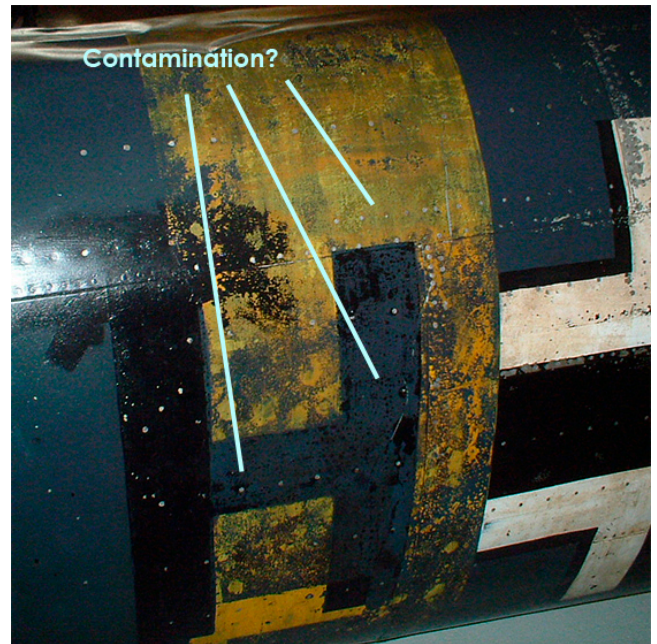
Some unusual “contamination” was found on both the rear fuselage and wing ailerons covering areas of the surface paint. This contamination caused the lacquer to show a changed, or distorted, colouration. When removed by light surface abrasion (1200 grit wet paper) the underlying paint showed normal colouration. This effect was also picked out by over-contrast photography (using a flash) along the fuselage. On the aileron, the contaminated areas of RLM 65 took on a ‘primer-like’ appearance, but subsequent testing revealed that this was typical RLM 65 lacquer. On the fuselage, both the appearance of RLM 22 and 04 were modified in the affected areas. The distortion of the 04 colouration was so pronounced that I spent quite a bit of time searching for RLM 27 pigments; none were found.

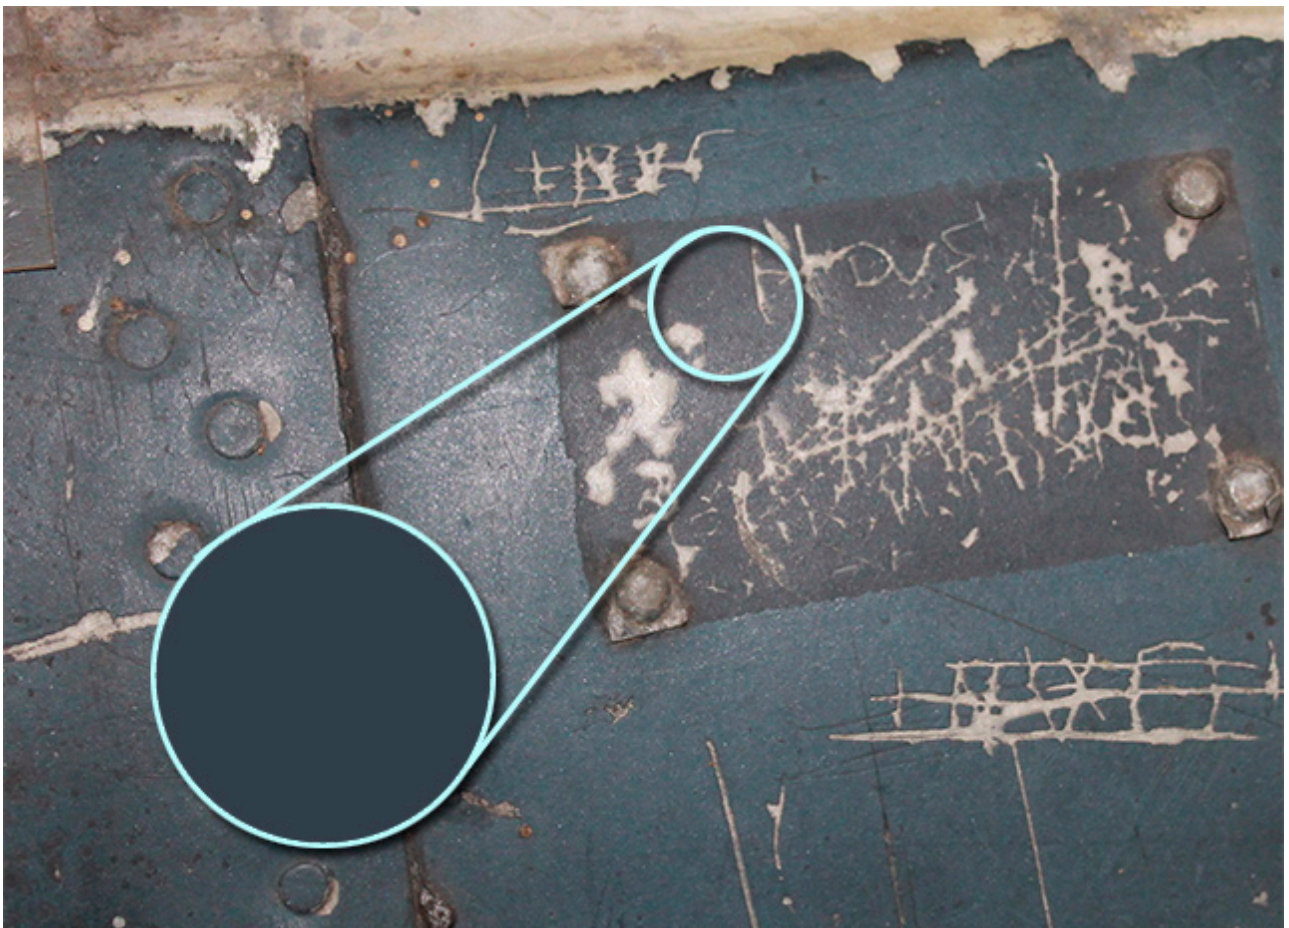
Unknown Blue Colour

One last colour mystery was entertained during the weekend's paint collection activities, this from a float in the museum gallery. The float belonged to a Bv 138 maritime aircraft which apparently went out of service in 1944. An unknown dark blue lacquer had been applied to the float professionally; e.g. not as an applique, but as the only main coating. This colour was seen on the upper surfaces in addition to the usual RLM 65 on the lower surfaces, and so we assume that this combination in fact represented the intended camouflage scheme (over this area).

A sample of the paint was not taken. Pursuant to earlier research conducted by notable *Luftwaffe* historian Michael Ullman, we believed that this paint represented physical evidence of Ullman's recently described RLM 83 Dunkelblau (Maritime). However, upon returning home I discovered that sufficient quantities of this paint were still to be found on my sandpaper so as to enable me to conduct a Ph test. This was done, and the result was conclusive: 7.6. I am convinced that this is the world's first recognised surviving sample of RLM 83. Mr Ullman will be contacted by Kjetil and myself and we will update this investigation as it proceeds.

I believe that the original appearance of this RLM 83 colour is similar to the digital recreation below.
